ACO Drain

KlassikDrain K100

PORTFOLIO

Lincoln Road Stage 1

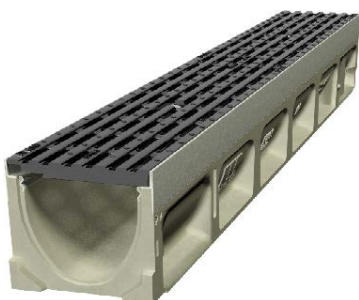
This project on Addigton's Lincoln Road started in winter 2020 and is turning damaged and dated buildings into a new and appealing retail development. ACO has been involved in the project, supplying threshold drainage along the facade of the building to prevent water from entering the buildings. ACO's KlassikDrain K100 together with **Heelsafe**® Anti-Slip galvanised longitudinal grates was chosen as an alternative E2 level entry solution for the ease of installation and superior hydraulic performance.

- ACO's KlassikDrain K100 with **Heelsafe**® Anti-Slip galvanised longitudinal grates, providing a pedestrian friendly surface water management.
- Certified to AS 3996 Class B loading, the grate matches the NZTA load requirements.
- AS 1428.2 (Clause 9c) compliant for wheelchair and walking cane safety.
