Otahuhu Recreation Centre

KlassikDrain KS100 with Type 492Q Grate

Otahuhu Rec Centre poolside drainage

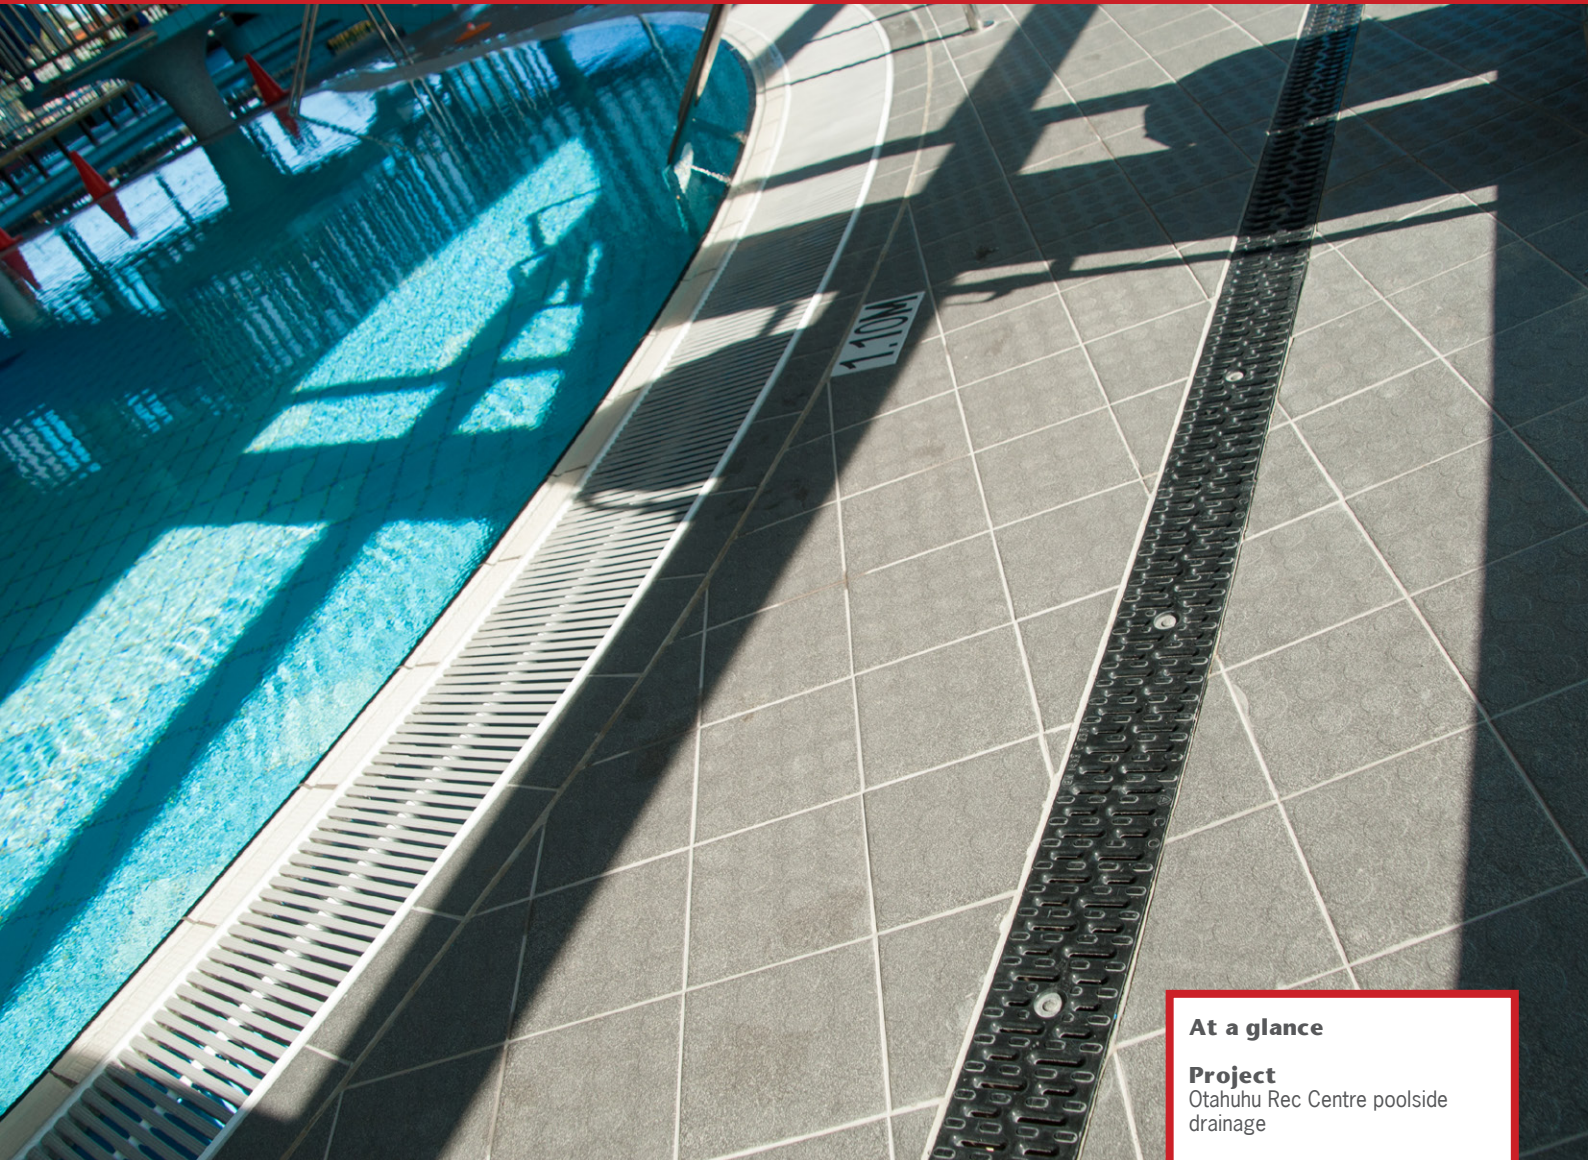
Designers specified ACO's KS100 KlassikDrain with a custom 316 stainless steel edge rail to combat the corrosive water. Type 492Q composite Heelsafe® anti-slip grates were installed throughout the internal areas. These grates are perfect for applications where chemical corrosiveness is an issue, and provide complete safety for pedestrians in the area.
