ACO Drain

KlassikDrain KS200

PORTFOLIO

### AC Baths Taupo

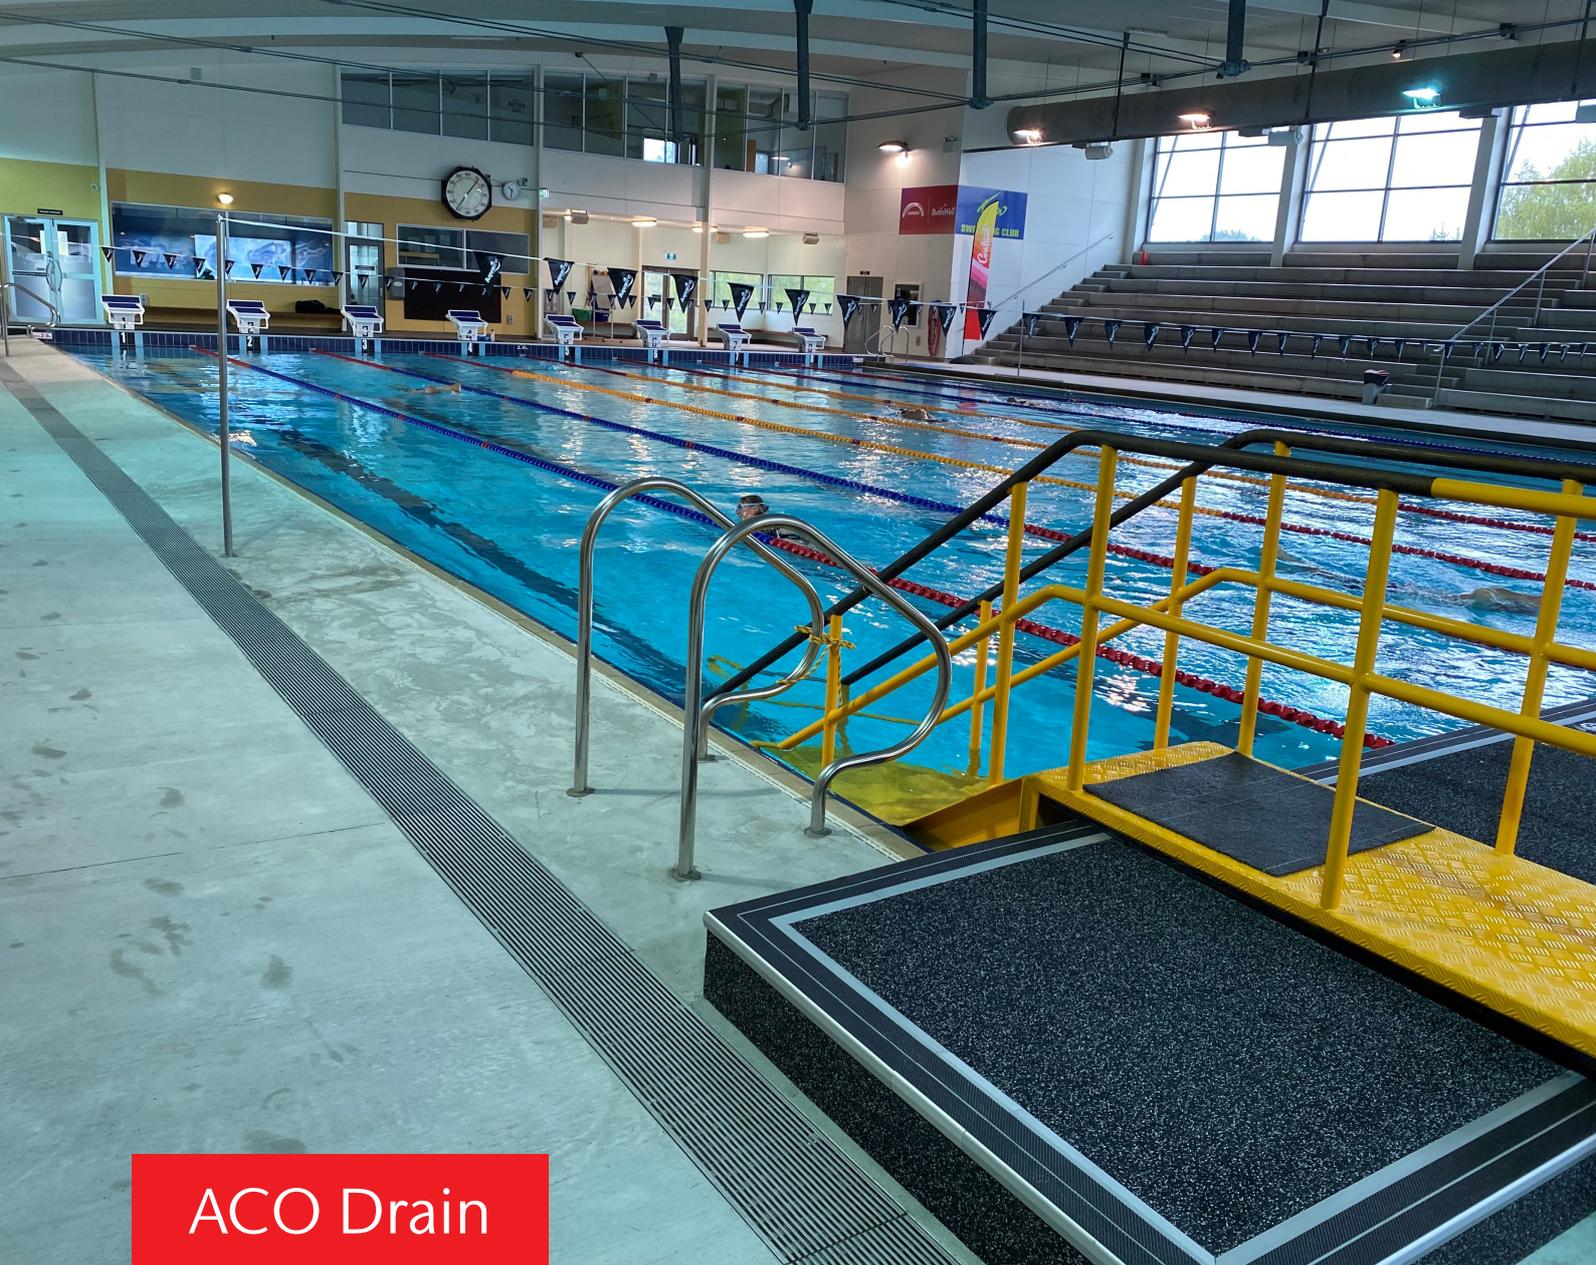
At the end of 2020 the AC Baths in Taupo have gone through a repair project for the indoor pools. Very aged existing drainage was no longer fit for purpose and had to be replaced. Therefore our sloping KlassikDrain KS200 together with stainless steel 5 Star **Heelsafe**® Anti-Slip grates were installed to capture the surface water along the pools. The new drains had to be easy to maintain and drain completely which is why a sloping system was essential. Especially for pool applications, it's important no ponding occurs and grates won't allow for any slipping hazards keeping visitors safe. Upon completion further KS200 drains were installed to improve drainage around some external pools.

- ACO's KlassikDrain KS200 with Stainless Steel 5 Star **Heelsafe**® Anti-Slip grates, providing visitor safety surface water management.
- Recesses in the edge rail fit around 'anti-shunt' lugs on the grate to prevent longitudinal movement.
- No end bars for visual continuity.
- Certified to AS 3996 Load Class B (80kN)
